Manhole Inspection Summary

Manhole # S21WW1045MH

Insp Date: **5/8/07 1:53 PM**

Location Address: **CROSS KEYS RD**

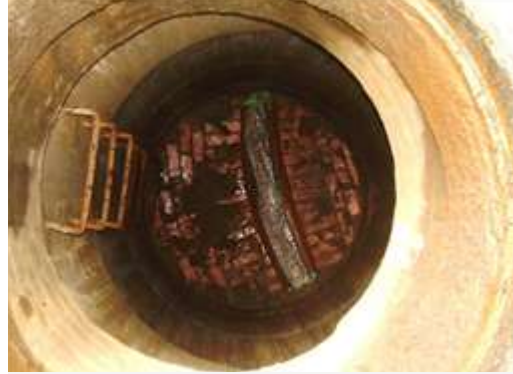
Top View

Evidence of surcharge - Bench debris.

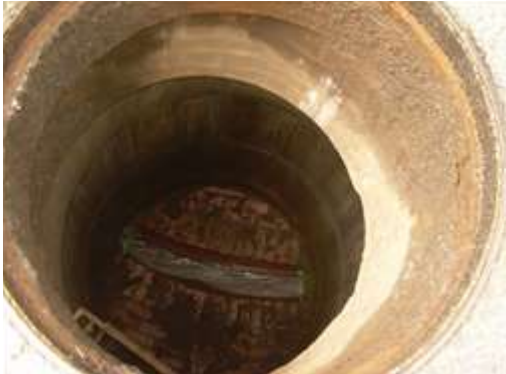
Defect

Frame leaks. Adjustment and Barrel infiltration - other side.

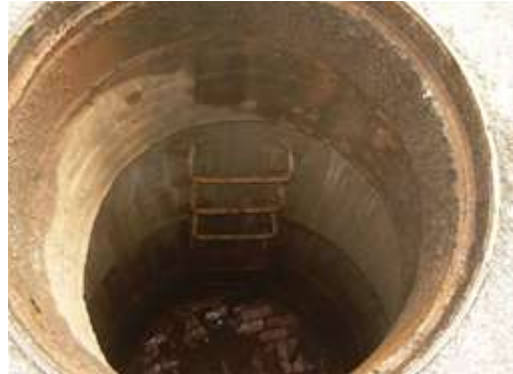
Defect

Frame leaks. Adjustment and Barrel infiltration.

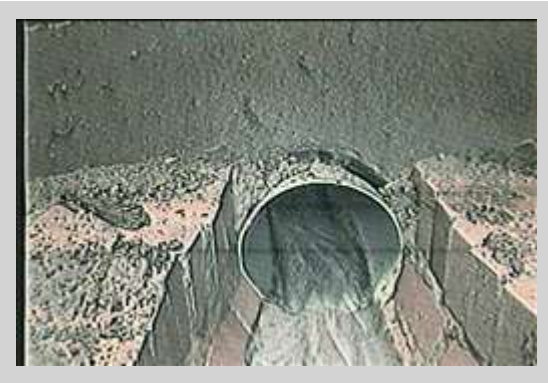
8 in. Circular Gravity Sewer Pipe Out @ 12 O'Clock

Channel deterioration.
